**Flood Control Project Maintenance
Levee Inspections**

Fall 2018 Levee Maintenance Deficiency Summary Report

Sacramento River Basin

Reclamation District No. 0551 Pearson

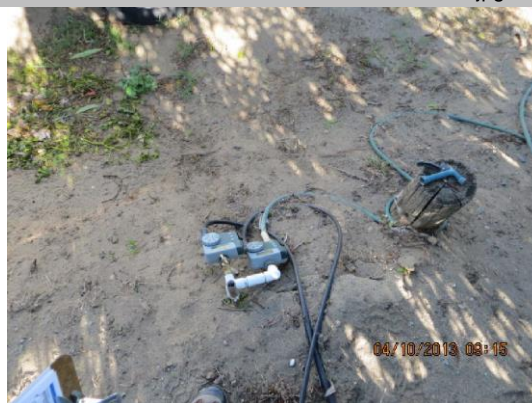
Photo 1 of 3 : UCIP_FA_2018_11705_19145.jpg

LM Start	0.41	Rating **	M	Issue No.	60
LM End	0.41	Issue Type +	En	Location *	
Category	Supplemental			GPS Latitude/Longitude	
				Start	End
Item	DWR UCIP Field Study			38.332039 °	38.332039 °
				-121.569730 °	-121.569730 °
DWR ID	21982				
Comment Code					
Inspector Comment					
FS_ID:11705 DS_ID:21982 EP_NO: 2759 Repair Type: Non-Urgent Crossing Status: Found UCIP Comments: Unclear where exact crossing is located. FIELD_STRUCT_DESC: [Courtland Boating Facilities] 1-inch steel water line through the levee, at an unknown depth. Ramp and boating facilities on the waterside (WS). Pipe visible under buildings at concrete foundation on the landside (LS). Water service connections for irrigation located on the WS slope. (Permit No. 2759, 1958 - Courtland Dock). [Additional Reference(s): DWR Levee Log, 2005]. FS Date: 4/10/2013

Irrigation pipes on WS slope.

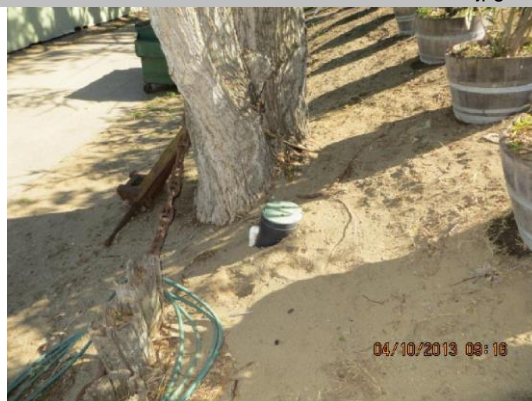
Photo 2 of 3 : UCIP_FA_2018_11705_19144.jpg

Irrigation pipes on WS slope.

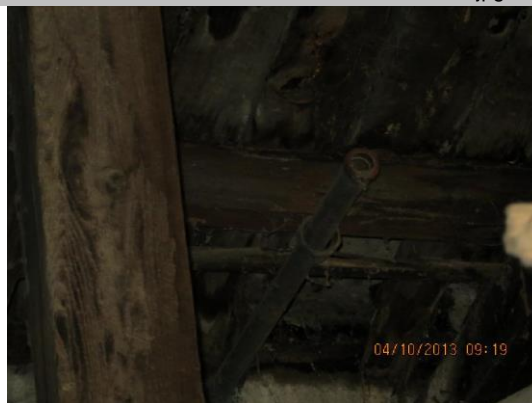
Photo 3 of 3 : UCIP_FA_2018_11705_19143.jpg

Various disconnected pipes visible at foundation/retaining wall under buildings on LS.

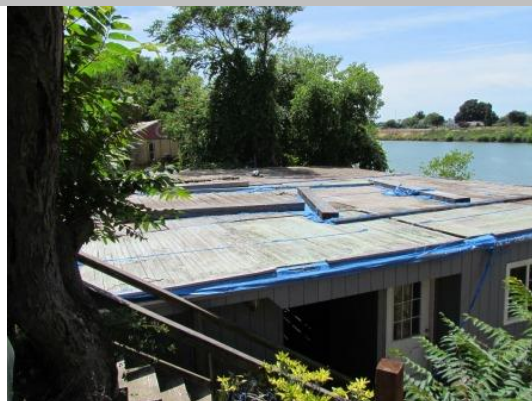
Photo 2 of 3 : FA_2018_RD0551_175_21_20180925_00008.jpg

Building remodeling project on waterside levee section. Photo taken 01-04-2014.

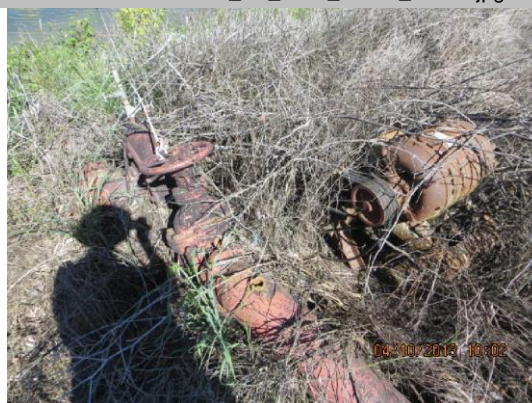
Photo 2 of 3 : UCIP_FA_2018_11726_19164.jpg

Pump, slide gate, and missing vent pipe on WS slope.

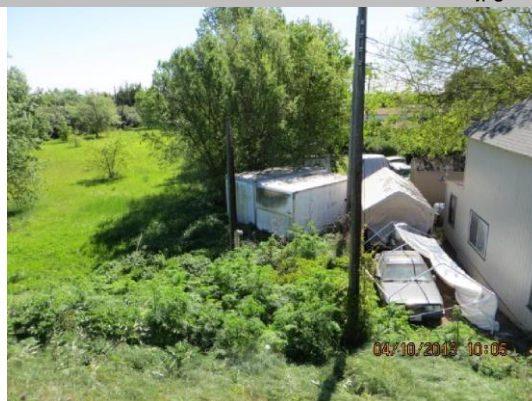
Photo 3 of 3 : UCIP_FA_2018_11726_19163.jpg

JP and pipe covered with vegetation on LS toe.

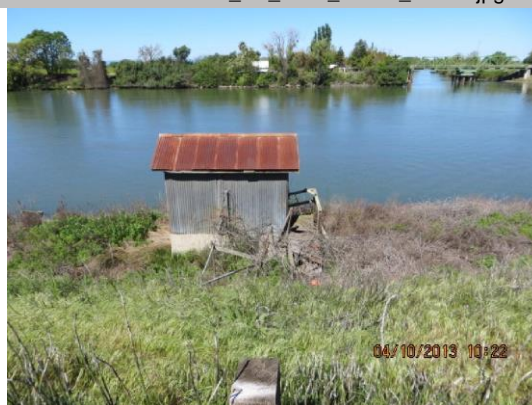
Photo 1 of 3 : UCIP_FA_2018_11727_19168.jpg

Comment Code					
Inspector Comment					
FS_ID:11727					
DS_ID:21986					
EP_NO: 701					
Repair Type: Non-Urgent					
Crossing Status: Found					
UCIP Comments: Pipe appears abandoned and should be done so properly. Good candidate for video inspection.					
FIELD_STRUCT_DESC: 14-inch steel irrigation pipe through the levee, 7.2 feet below the crown. Pump in pump house on the waterside (WS) slope. Service pole on the landside (LS) slope. 1-inch galvanized filler pipe, and a 2-inch electrical conduit at the same location. (Permit No. 701, 1937 - American Trust Company). [Additional Reference(s): DWR Levee Log, 2005. USACE Sacramento O&M Manual 111, May 1959, (RM 33.91)].					
FS Date: 4/10/2013

Pump house and pipes visible on WS slope.

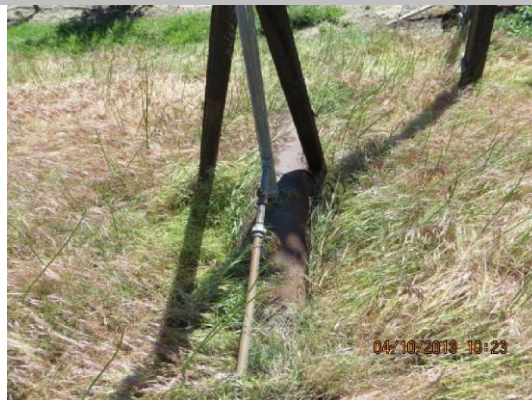
Photo 3 of 3 : UCIP_FA_2018_11727_19166.jpg

galvanized iron filler pipe and 16-inch pipe visible at LS toe.

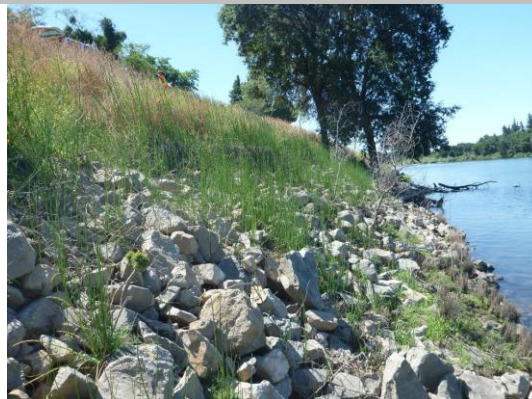
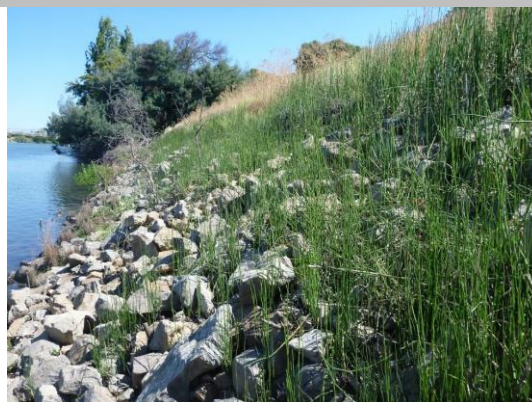
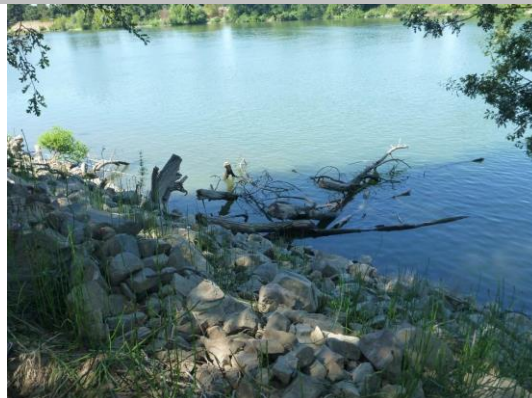
Comment Code					
Inspector Comment					
Levee Evaluation Comments					
Description:District Station 84+15 to 87+60, Sec. 06, T. 5 N. R. 4 E., M.D.M. Approximately 135 linear-feet of erosion/sloughing exists along the waterside levee slope of the Sacramento River. Sloughing commences approximately 3/4 of the way down the slope from the crown and extends into the rip rap. Some existing rip rap has been pulled off in this section.					
Site ID No:331					
Site Designation:LMA-158					
Repair Type: Erosion					
Rating:Area of Concern					
Field Date:7/13/2017					
Notes: thorney veg on upper slope, light veg within rip rap. Crown is a paved road. 1 ft vertical scarp max just above rip rap so we rated it as a lower priority.

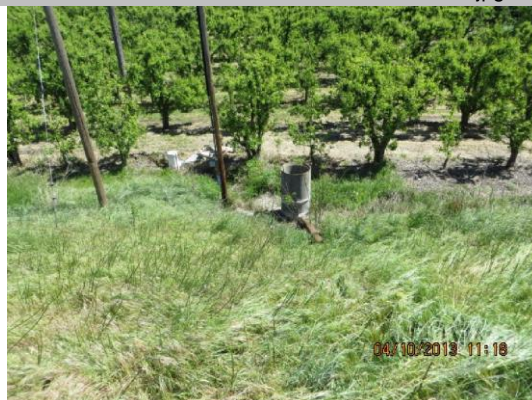
Photo 2 of 3 : UCIP_FA_2018_26874_49595.jpg

36-inch concrete standpipe at LS toe.

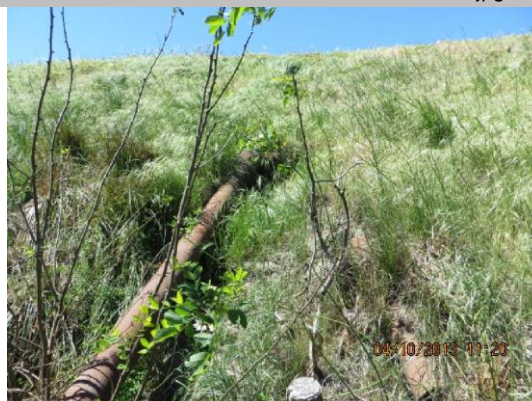
Photo 3 of 3 : UCIP_FA_2018_26874_49594.jpg

Comment Code						
Inspector Comment						
FS_ID:26874						
DS_ID:21990						
EP_NO: 11145						
Repair Type: Non-Urgent						
Crossing Status: Found						
UCIP Comments: Based on District notes from January 14, 2014, pump discharge pipe has been repaired. Pipe failing on LS slope causing erosion along pipe alignment. Pipe debris on both slopes should be removed as well.: As of 12/13/2013 District President noted that the landowner had made repairs to the LS slope leaks.: As of 12/17/2013 District submitted letter to landowner explaining UCIP report details including photos of the pipe problems						
FIELD_STRUCT_DESC: 10-inch irrigation pipe of an unknown material through the levee, 4.7 feet below the crown. Pump in a 7-foot by 9-foot concrete pump house on the waterside (WS) slope. 36-inch concrete riser on the landside (LS) toe. 1-inch electrical conduit at the same location. Service pole at the LS toe. (Automatic Board Order (ABO) issued as Permit No. 11145, 1975 - Horace D. and Lucile Towne). [Additional Reference(s): DWR Levee Log, 2005. USACE Sacramento O&M Manual 111, May 1959, (RM 33.02), listed as an 8-inch pipe].

Pipe failing on LS slope due to corrosion holes causing erosion.

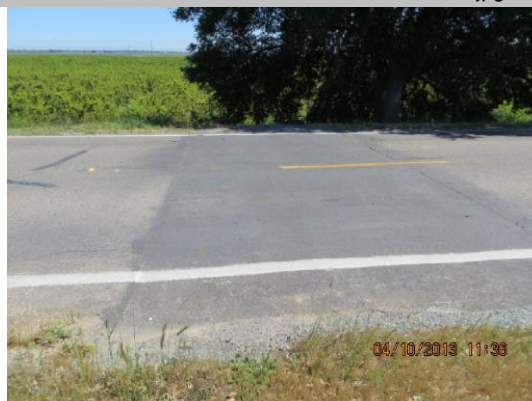
Photo 1 of 1 : UCIP_FA_2018_11749_19217.jpg

Comment Code						
Inspector Comment						
FS_ID:11749 DS_ID:22040 EP_NO: 3676 Repair Type: Non-Urgent Crossing Status: Not Found UCIP Comments: Fresh cut through pavement on crown indicates recent work on pipes at this location. Need to determine if pipe was removed or abandoned in place. FIELD_STRUCT_DESC: 2 of 2: 8-inch coated steel irrigation pipe through the levee, 5 feet below the crown. 8-inch pipe sleeved through a 12-inch pipe. Pump on platform on the waterside (WS). (Permit No. 3676, 1961 - Runyon and Dorsey). [Additional Reference(s): DWR Levee Log, 2005. USACE Sacramento O&M Manual 111, May 1959, (RM 33.02)]. FS Date: 4/10/2013

Fresh cut through pavement at crown.

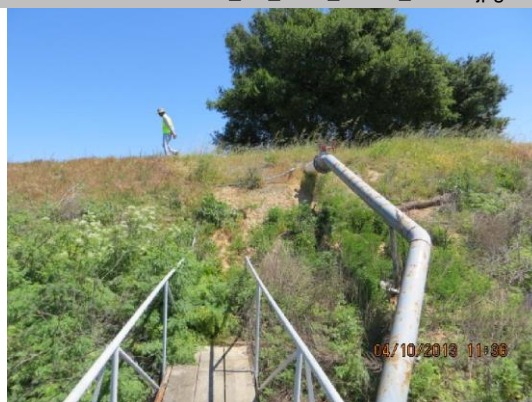
Photo 1 of 3 : UCIP_FA_2018_11763_19222.jpg

Pipe, butterfly valve, and electrical conduit 3-feet below the crown on the WS shoulder.

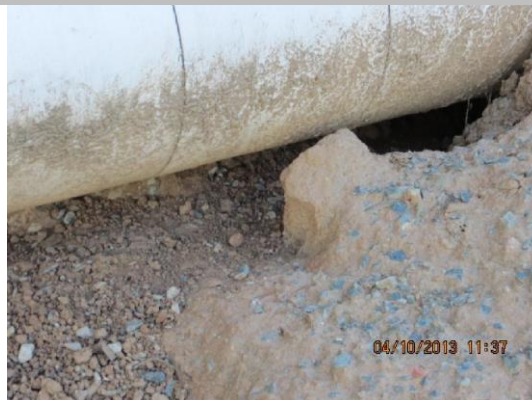
Photo 3 of 3 : UCIP_FA_2018_11763_19220.jpg

Comment Code						
Inspector Comment						
FS_ID:11763 DS_ID:21991 EP_NO: 6551 Repair Type: Non-Urgent Crossing Status: Found UCIP Comments: Rodent activity undermining pipe on LS slope. FIELD_STRUCT_DESC: 1 of 2: 14-inch polyvinyl chloride (PVC) wrapped steel irrigation pipe through the levee, 3 feet below the crown. Butterfly valve on the waterside (WS) shoulder. 2-inch galvanized electrical conduit at the same location. Pump on pile structure on the WS toe. Pressure booster and pump on the landside (LS) toe. (Permit No. 6551, 1969 - John D. Wheeler). [Additional Reference(s): DWR Levee Log, 2005. USACE Sacramento O&M Manual 111, May 1959, (RM 32.78)]. FS Date: 4/10/2013

Rodent activity undermining pipe on LS slope.

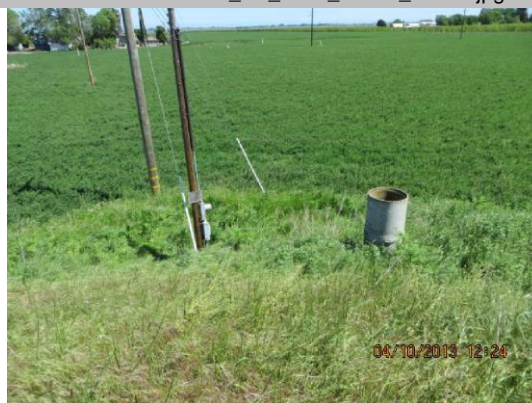
Photo 1 of 2 : UCIP_FA_2018_11783_19241.jpg

Comment Code						
Inspector Comment						
FS_ID:11783 DS_ID:21994 EP_NO: 11141 Repair Type: Non-Urgent Crossing Status: Found UCIP Comments: Records indicate this pipe was abandoned, but it appears to be active. Verify status. FIELD_STRUCT_DESC: 10-inch steel irrigation pipe through the levee, 8 feet below the crown. Slant pump on the waterside (WS) slope. Service pole on the landside (LS) slope with a 1.5-inch galvanized iron electrical conduit through the levee at the same location. (Automatic Board Order (ABO) issued as Permit No. 11141, 1975 - Adele Runyon, et al.). [Additional Reference(s): DWR Levee Log, 2005. USACE Sacramento O&M Manual 111, May 1959, (RM 32.38), listed as a 12-inch pipe]. FS Date: 4/10/2013

JP and concrete standpipe on LS toe.

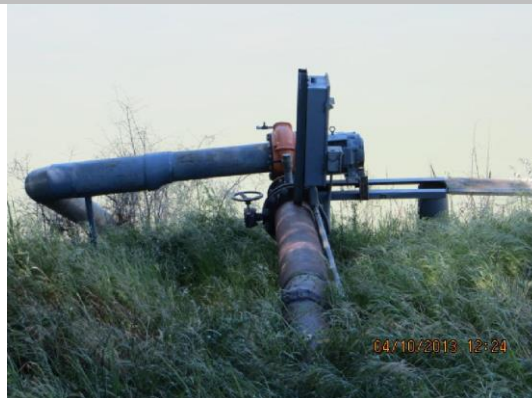
Photo 2 of 2 : UCIP_FA_2018_11783_19240.jpg

Pump, pipe, and butterfly valve on WS slope.

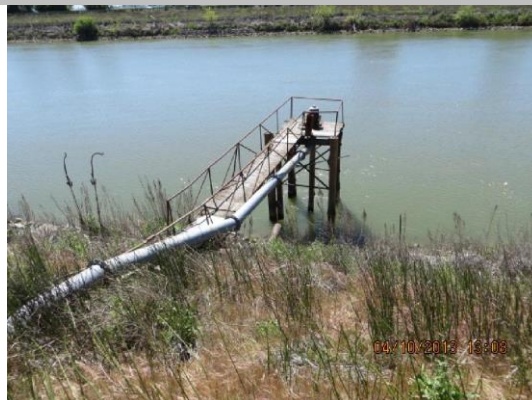
Photo 2 of 2 : UCIP_FA_2018_11803_19260.jpg

10-inch steel irrigation pipe and steel pump structure on WS toe.

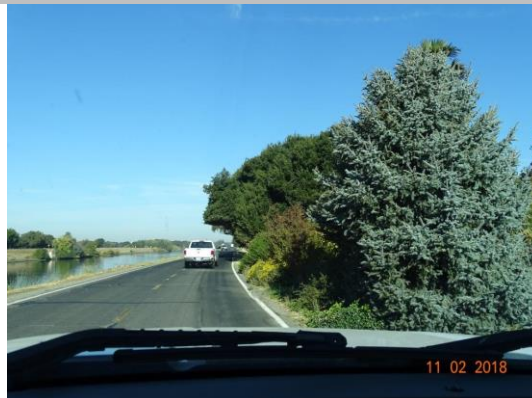
Photo 1 of 1 : FA_2018_RD0551_175_56_20181102_00112.jpg

View looking upstream at landscaping on the land side slope (November 2018).

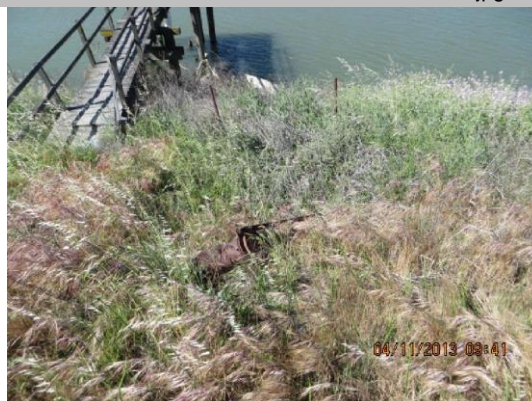
Photo 1 of 2 : UCIP_FA_2018_11817_19287.jpg

Abandoned slide gate on WS slope.

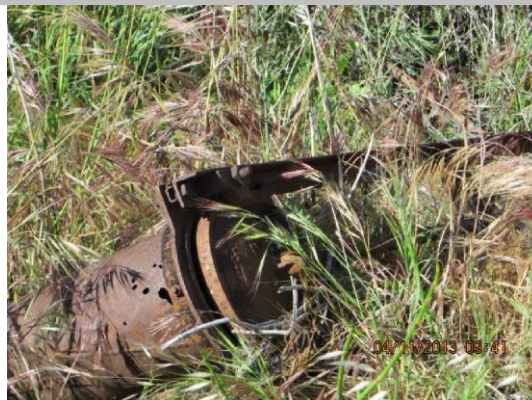
Photo 2 of 2 : UCIP_FA_2018_11817_19286.jpg

Abandoned slide gate on WS slope.

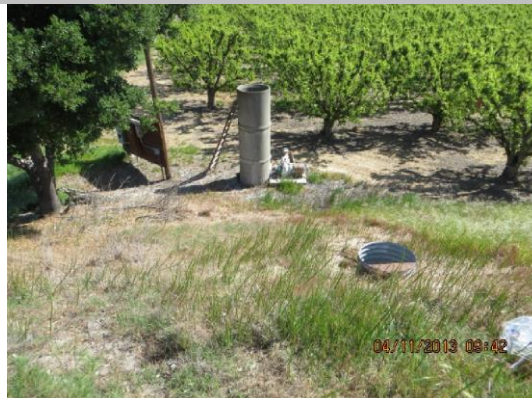
Photo 1 of 2 : UCIP_FA_2018_11823_19301.jpg

24-inch CMP riser and 48-inch concrete riser on LS slope.

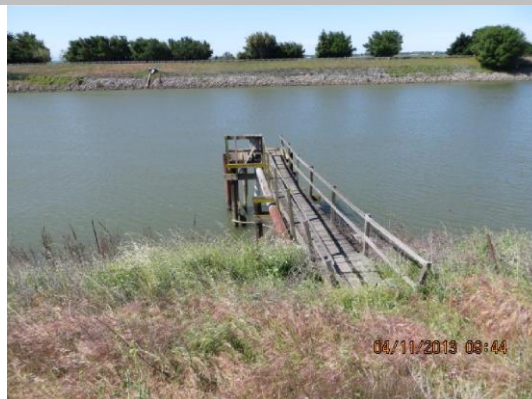
Photo 2 of 2 : UCIP_FA_2018_11823_19300.jpg

Pump on pier with wooden walkway on WS toe.

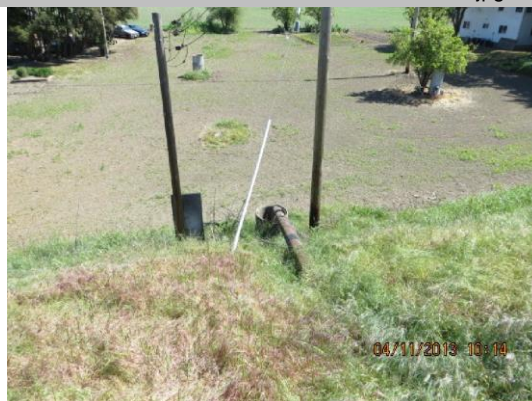
Pipe and stand pipe on LS toe with subsidence along pipe on LS slope.

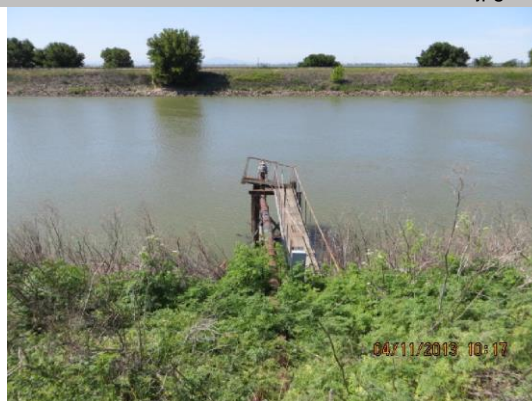
Pump on pier showing structural failure on WS toe.

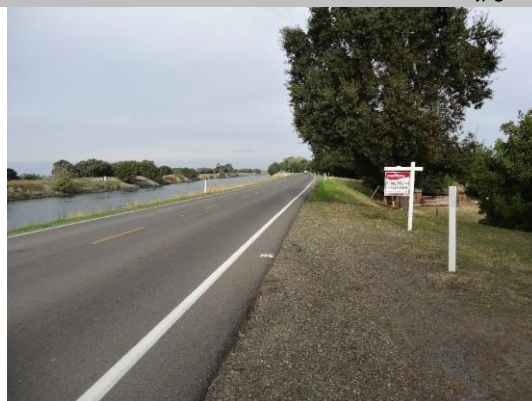
View of levee crown and LS slope, photo taken downstream of crossing looking upstream.

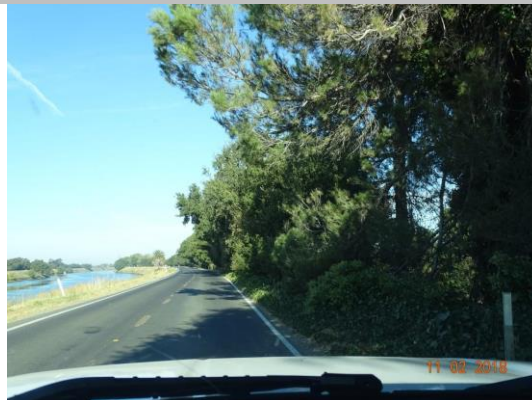
View looking upstream at landscaping on the land side slope (November 2018).

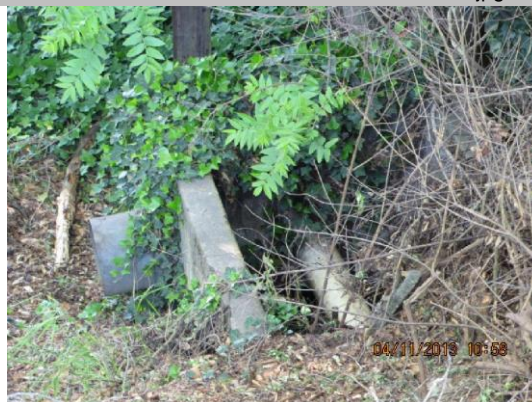
Pipe in distribution box at LS toe.

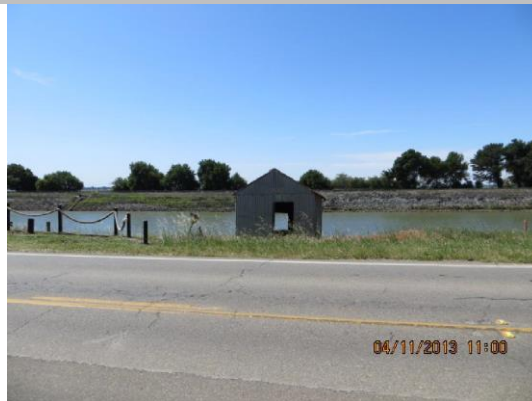
Relocated pumphouse on WS shoulder.

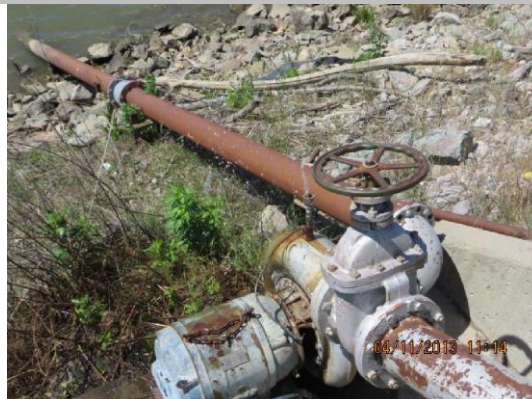
Pump and slide gate at Concrete pad on WS slope.

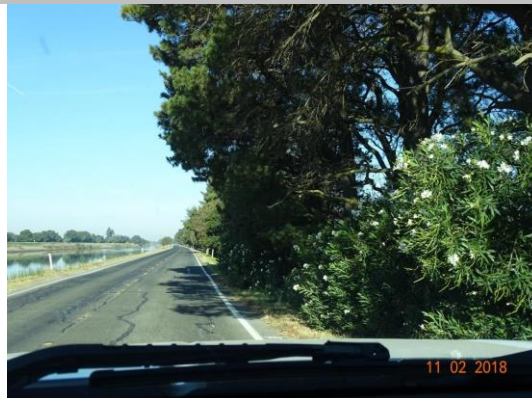
View looking upstream at land scaping on the land side slope (November 2018).
